# SEVEN BRIDGES RAVINE AT GRANT PARK RESTORATION CONCEPT PLAN

PREPARED FOR THE FRIENDS OF GRANT PARK &  
MILWAUKEE COUNTY PARKS

OCTOBER 2024

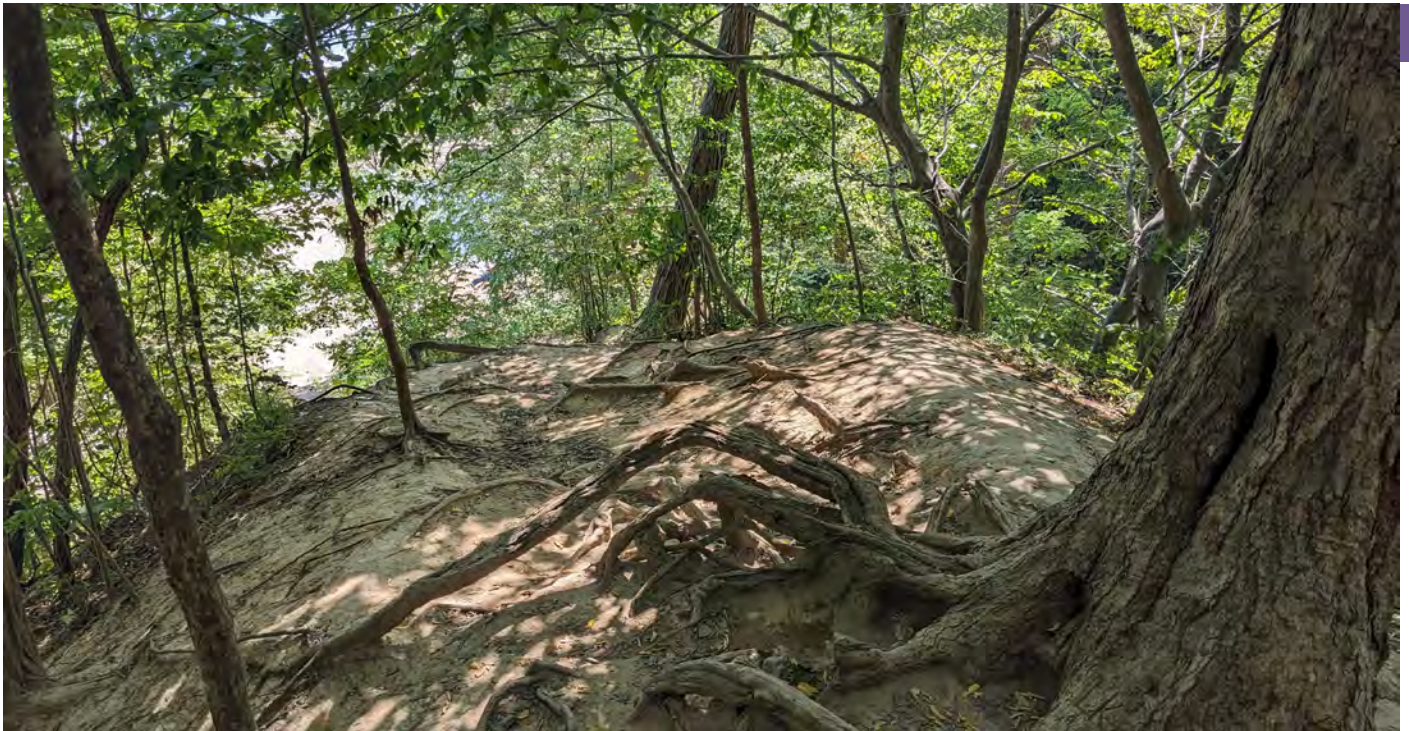
*Bluff erosion at mouth of ravine at Lake Michigan.*

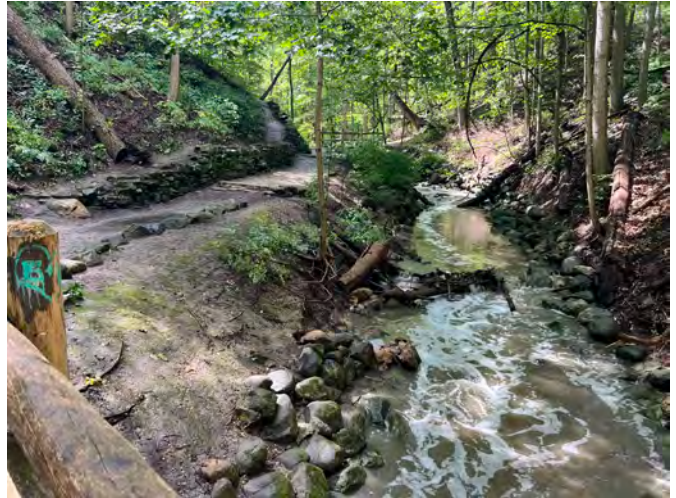
*Eroding banks and turbid water after a storm.*

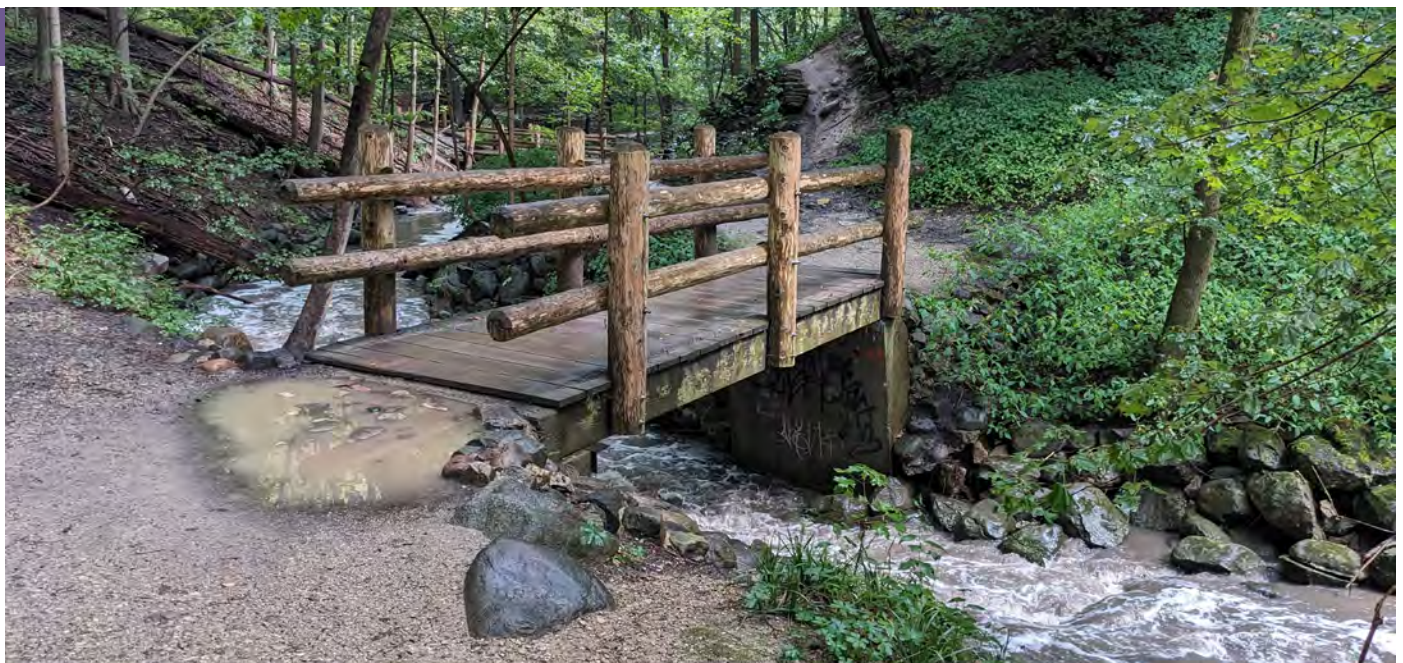
*Erosion around bridge foundations and turbid water after a storm.*

In areas where erosion is actively occurring, stones should be added to the banks up to the bankfull elevation (approximately four feet above the channel bottom). Rounded natural Wisconsin granite boulders will match the stream and ravine area's existing character. These boulders will also help protect existing bridge foundations from wash-out. This work should be coordinated with County Parks and upcoming bridge abutment repairs.

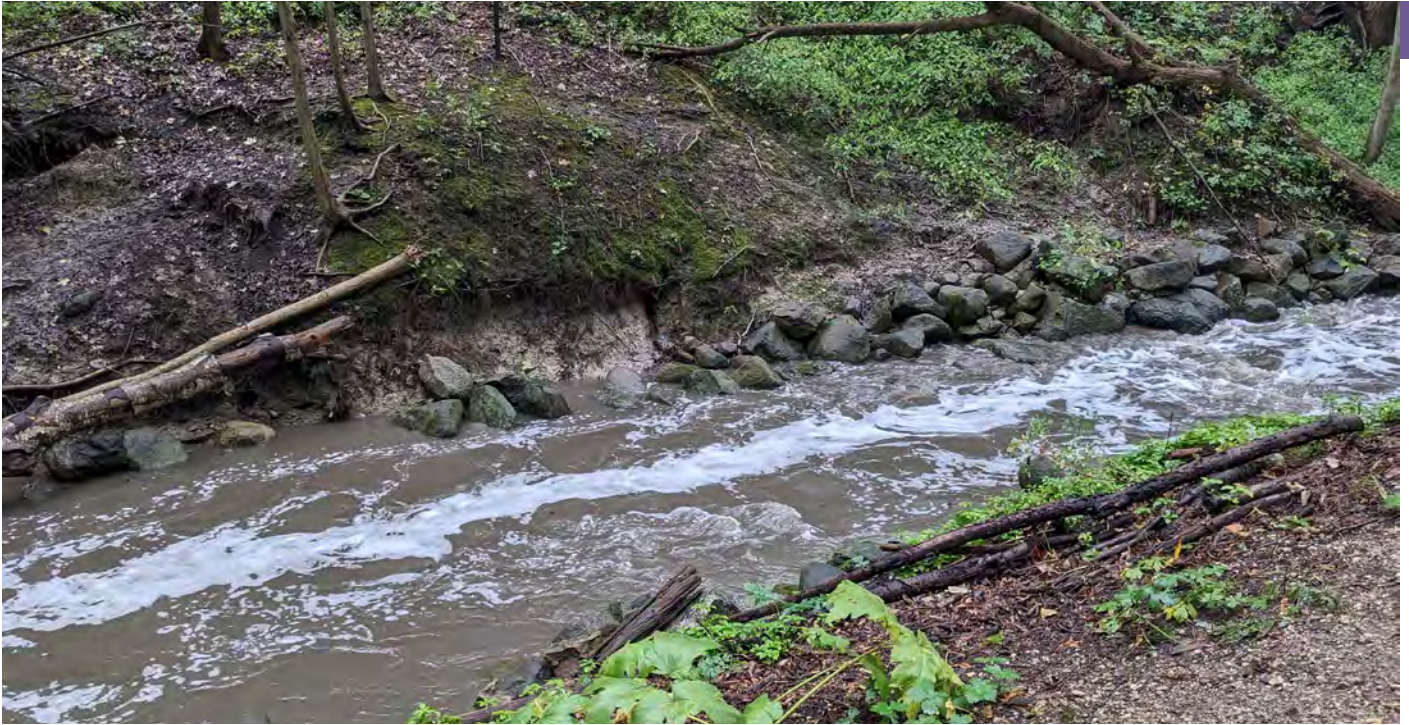
*Erosion at the toe of the ravine slope, threatening upper parts of the hillside.*

Incised slopes should be regraded from the toe of the slope or top of stone toe protection to stable vegetated ground. During the design phase, care should be taken to minimize earthwork by balancing the amount of material to be imported or exported. Newly graded slopes should be seeded, covered with erosion control blanket, and planted for stabilization, water quality, and habitat.

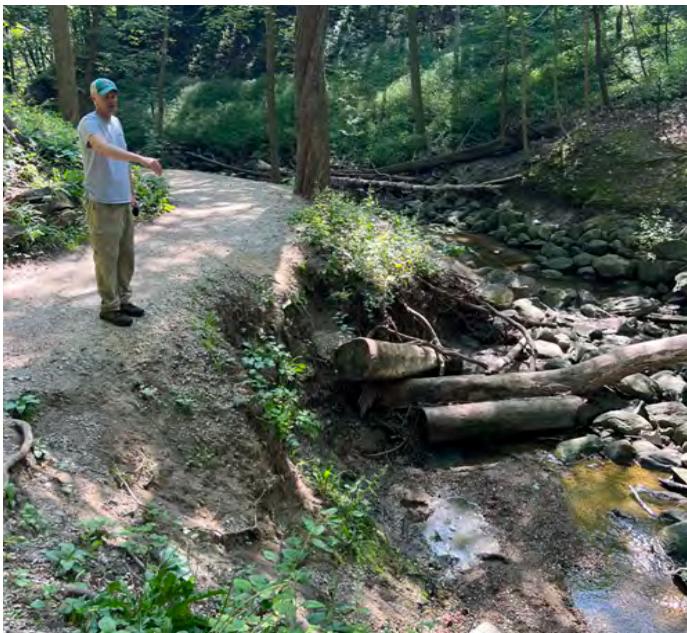
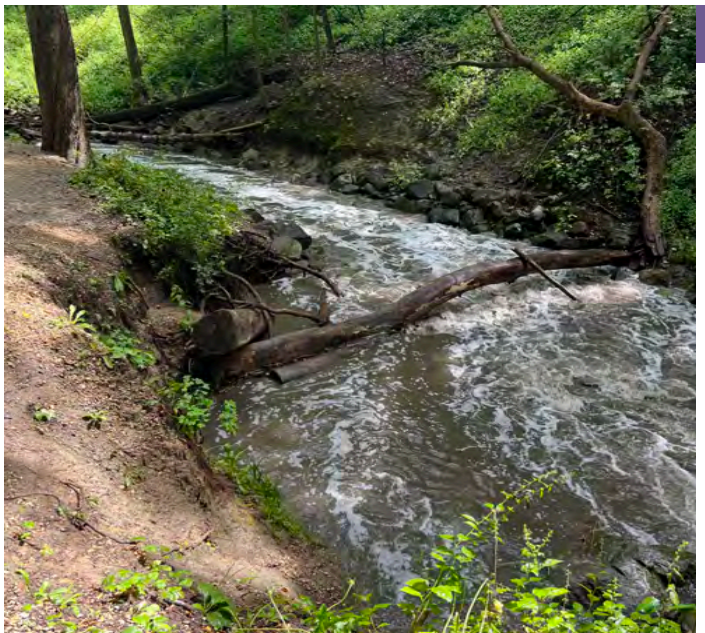
*Bank erosion threatening an adjacent trail that serves as the main access path to the beach shown at low water level and immediately after a short storm.*

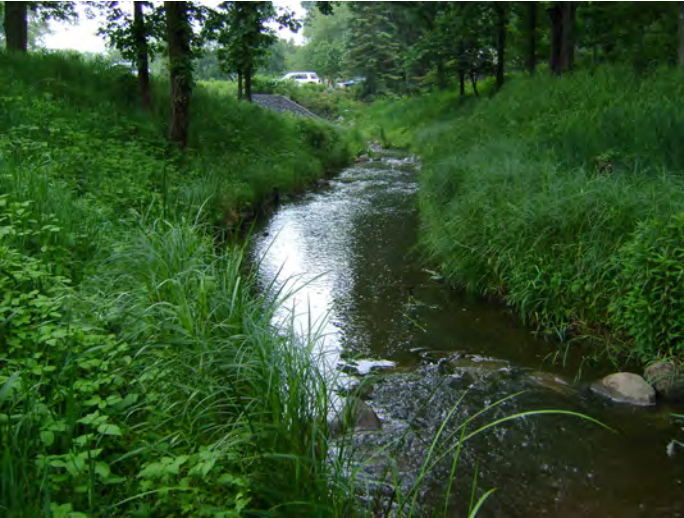
*Example stream condition: Vegetated stream banks with cross vane structure.*

Although head-cutting does not appear to be a major issue in the ravine stream, existing riffle structures have shifted, causing streambank erosion. Larger stones should be added to these riffles to prevent further shifting and direct water flow toward the center of the stream, reducing pressure on the banks and improving habitat. Debris jams that cause similar issues should be removed.

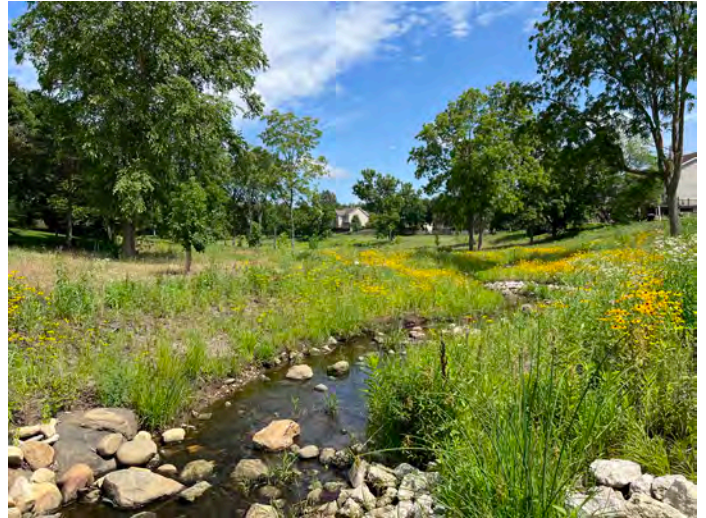
*Example stream condition: Vegetated stream banks with riffle structure.*

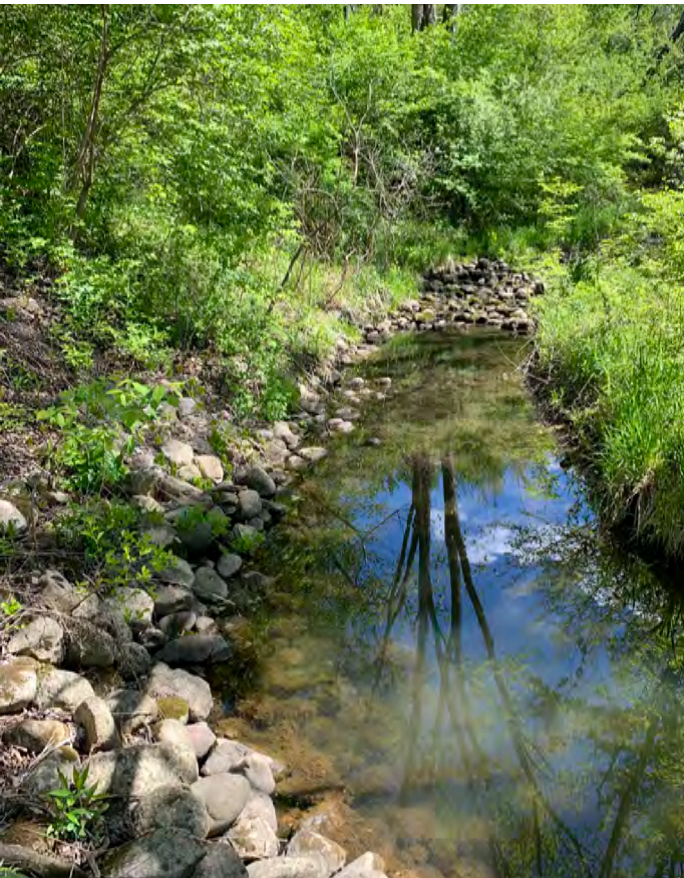
*Example stream condition: Natural stone toe protection and riffle in-stream structure.*

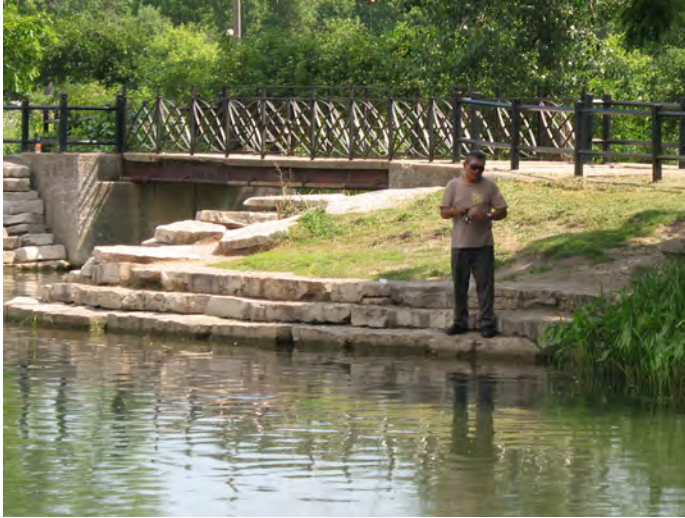
*Example water access: Stacked outcropping stone at key points along stream.*

To address erosion caused by visitors trying to access the water, stacked outcropping stone can be added at key areas to provide stable access points, preventing further damage along the stream. This sanctioned access will serve as a point of least resistance and will help prevent new desire paths up and downstream.

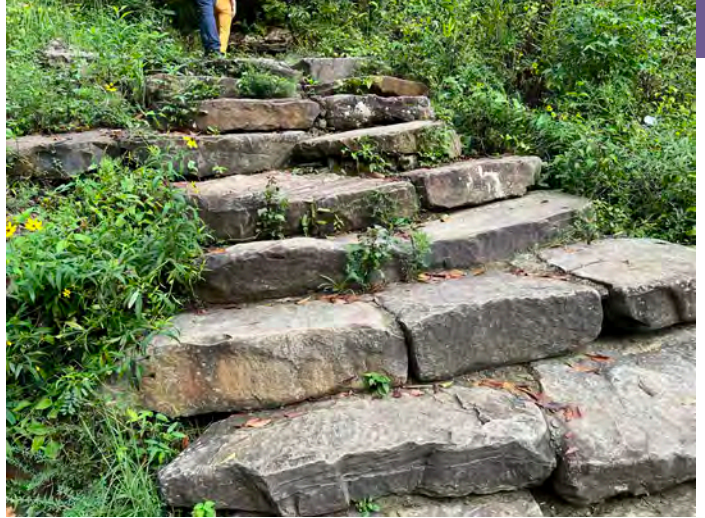
*Example water access: Stacked outcropping stone at key points along stream.*

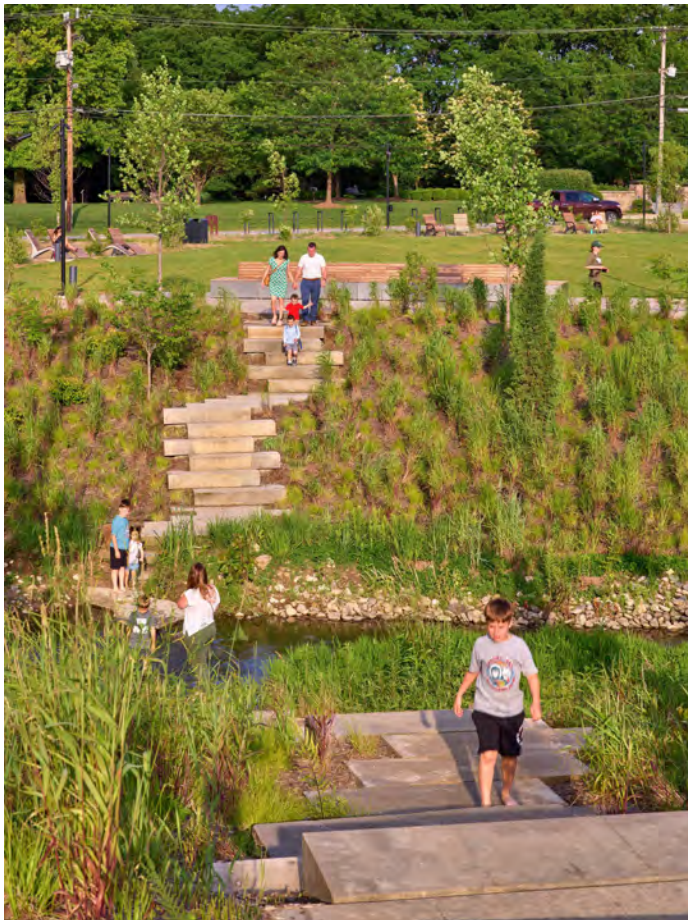
*Example water access: Stacked cut stone at key points along stream.*

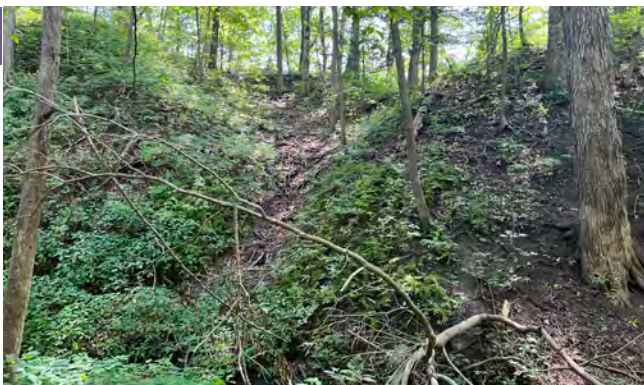
*Existing slope condition: Spotty areas of bare soil.*

All bare soil areas within the project site should be seeded with a woodland seed mix that includes species native to the ravine ecosystem. Seed can be collected on-site or sourced from other local areas. It is estimated that roughly one-third of the project area will require seeding, including streambanks, trampled areas, and other ravine slopes that have washed out or where Norway maples have reduced groundcover.

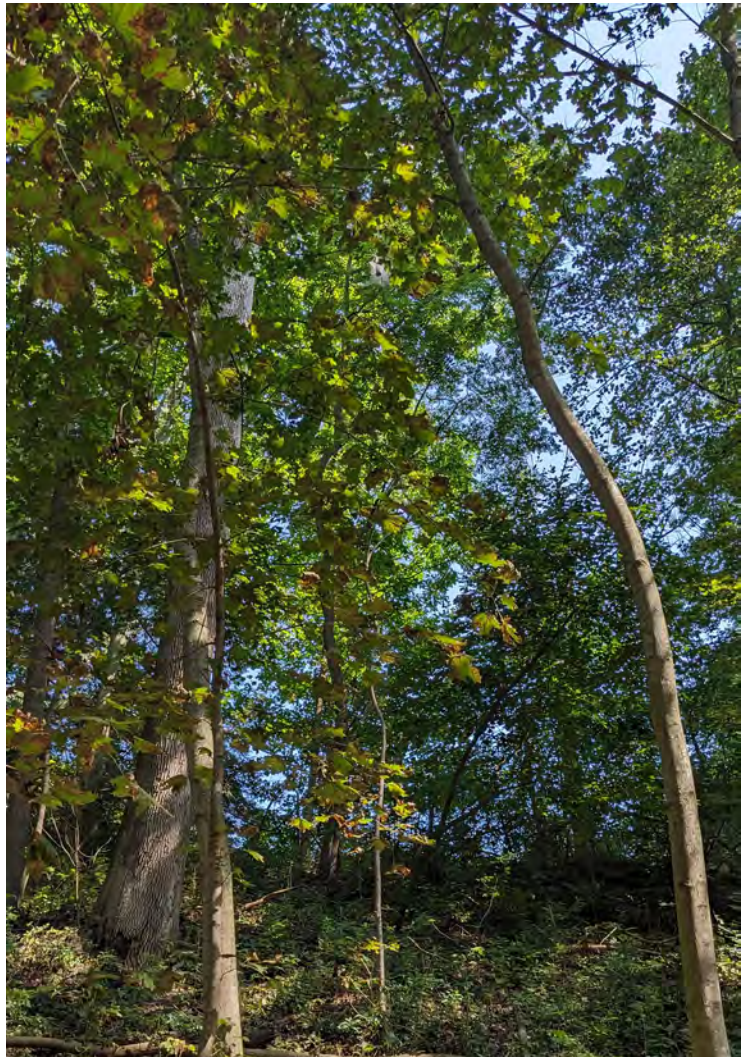
*Existing vegetation: Norway maples on ravine slopes.*

The selective removal of Norway maple trees along streams and on ravine slopes is recommended to gradually phase out this non-native species from the canopy. This wood can be utilized for stream restoration, trail edging or other restoration activities. Ongoing management of other invasive species, such as garlic mustard, buckthorn, and honeysuckle, should continue through hand-pulling where possible and cutting and spot-treating with herbicide when necessary. Additionally, areas with *Euonymus fortunei* near Lake Michigan should be closely monitored to ensure it does not spread or invade other areas of the park.

Native trees, such as white oak, shagbark hickory, and sugar maple, should be planted to replace the removed Norway maples. Native shrubs should also be planted in areas like the tops of walls to deter foot traffic and remote control car use. In slope restoration areas or adjacent to narrowed trails, supplemental plug plantings should be added to accelerate vegetation establishment and improve species diversity.

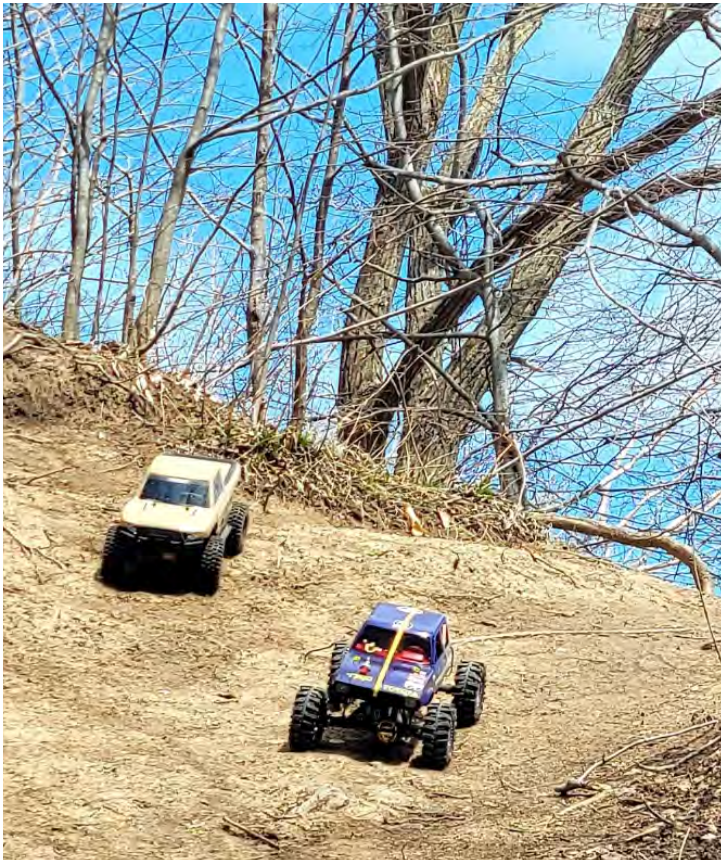
*Existing bluff erosion and off-trail remote control car use. Image from Google Maps.*

In areas where trampling has compacted the soil, it should be lightly tilled or disked before seeding or planting to improve soil quality. Some bluff areas have eroded so severely that tree roots are exposed due to the loss of topsoil and sand. In these locations, new soil should be brought in to restore the original grade before seeding or planting. This effort should be coordinated with stream restoration grading to balance the earthwork, minimizing the amount of material that needs to be imported or exported.

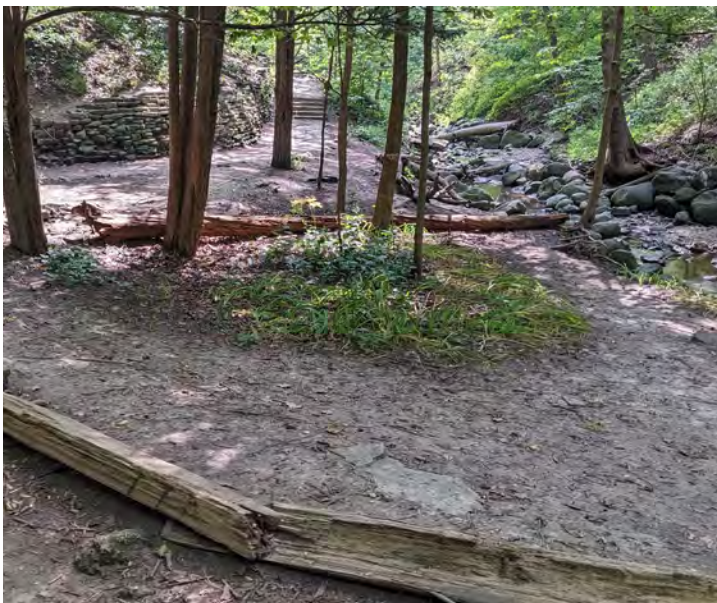
*Loss of vegetation due to off-trail use to be planted.*

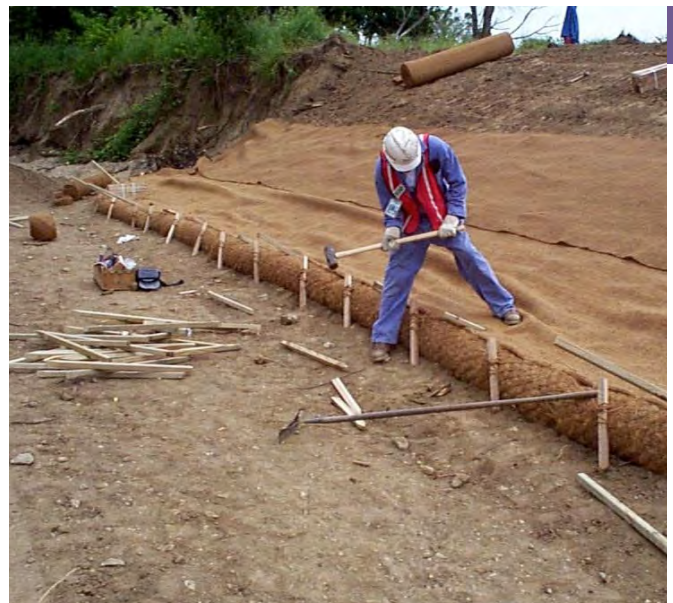
*Proposed erosion control approach with erosion control fabric and coir logs.*

Biodegradable erosion control fabric with a lifespan of 36 months should be used to stabilize slopes while seeds and plants are becoming established. Coir logs, embedded in the ground every five vertical feet along the contour lines, can further improve erosion control and help with the establishment of vegetation. All bluff restoration shall follow the Milwaukee County Coastline Management Guidelines.

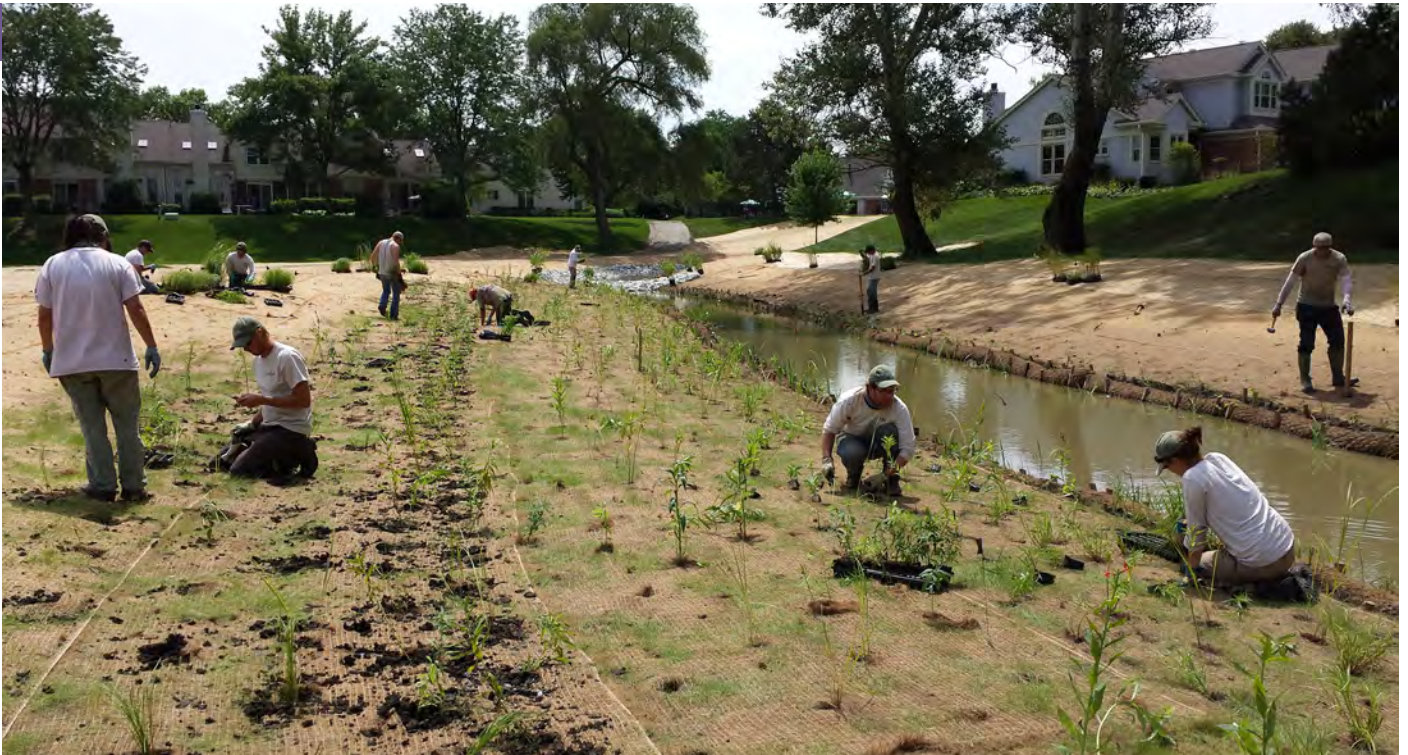
*Proposed plug planting through erosion control fabric after seeding.*

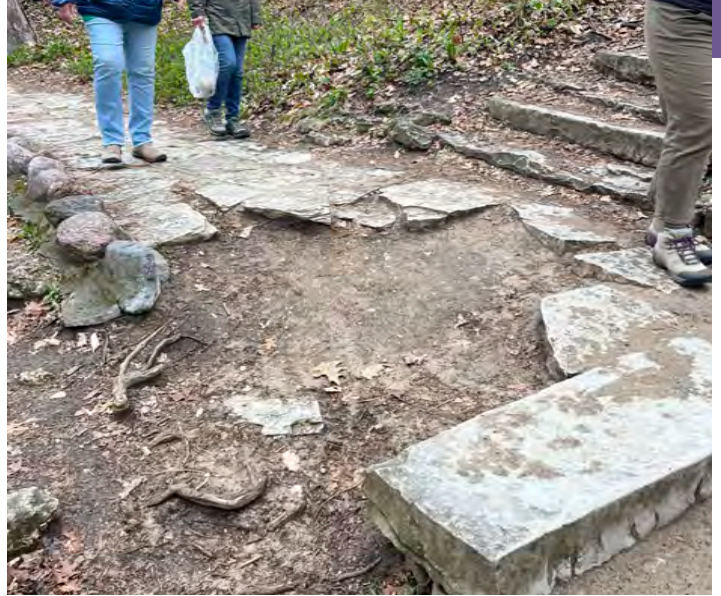
*Existing stair landing with missing lannon stone paving and adjacent wash-out.*

Many of the trail areas consist of dirt paths that have expanded due to visitors walking off-trail. Adding a standard trail surface, such as gravel, can help define the trail limits and strengthen the walking surface. Gravel also drains water quickly, preventing the formation of muddy areas that often lead to the creation of new, undesigned trails. The historic paths were constructed with lannon limestone slabs, many of which remain today, though some have been covered or are missing. Stones around bridge landings should be reset to ensure they are level with the bridge surface, and new lannon stone should be installed to fill in gaps at the bottom of existing stairs and near the main bridge by the lake.

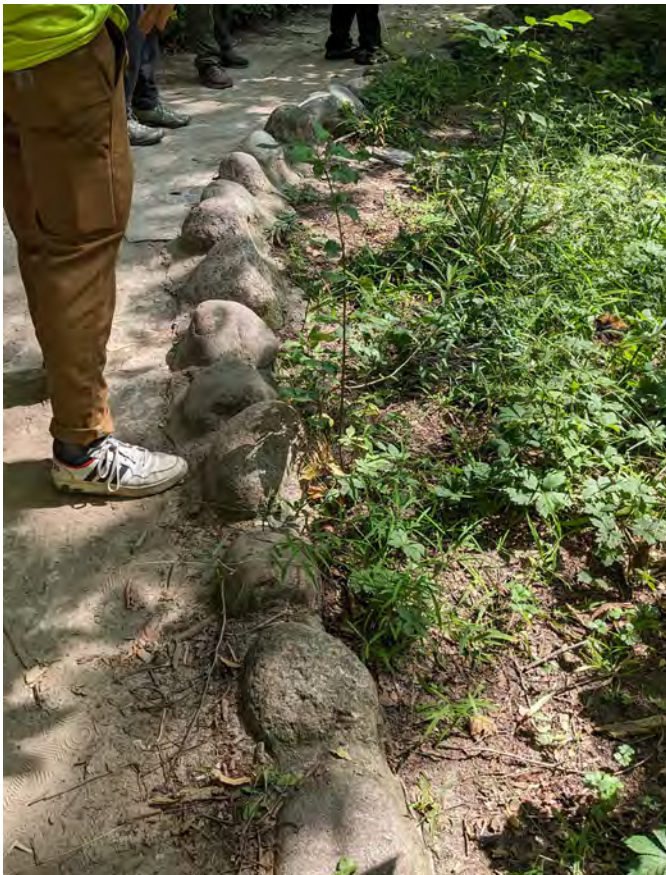
*Existing example of boulder trail edging successfully preserving adjacent vegetation.*

In parts of Grant Park, granite boulders and fallen logs have been used as trail edging to keep visitors on the designated paths. Extending this approach to the upper bluff trails and along the stream will help define the walking surface and provide a high-ground area for visitors to step onto during wet conditions. Granite boulders embedded in the ground will also serve as excellent edge restraints for the lannon stone paths and should be added where edging is missing.

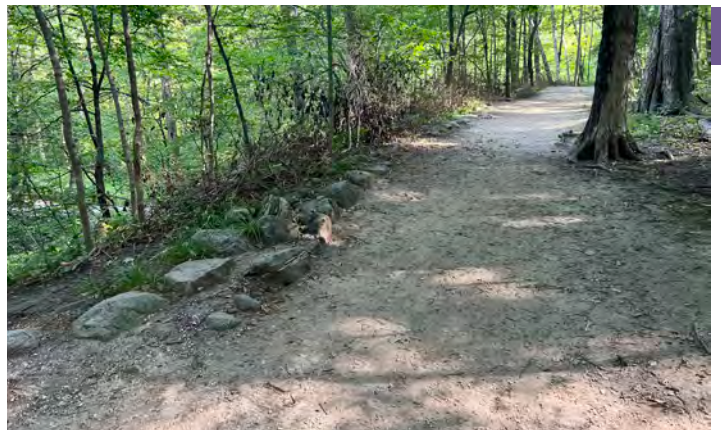
*Existing trail with boulder edge protecting slope vegetation and opposite side without edging expanding.*

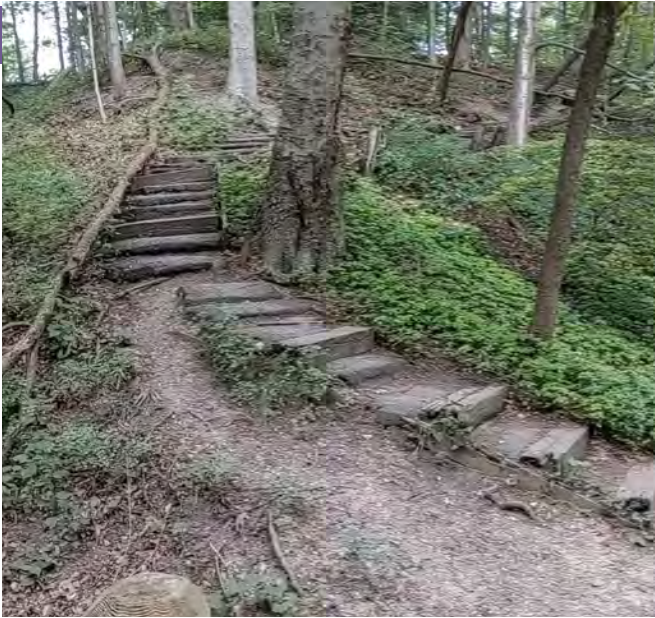
*Existing timber stair in disrepair to be removed.*

Two existing sets of stairs are in poor condition. The first is an old timber stair with small sections of asphalt between steps. It lacks a handrail, and the steps are crumbling and eroding. This stair receives little use and should be removed. The second stairway, made of limestone, connects to the upper bluff trails but is cracked, uneven, and lacks a handrail. Additionally, its bottom is located in an area that is not intuitive to beachgoers, causing visitors to traverse the slope instead. Assess existing stones from the stair for potential reuse for a new stair or for paving stones.

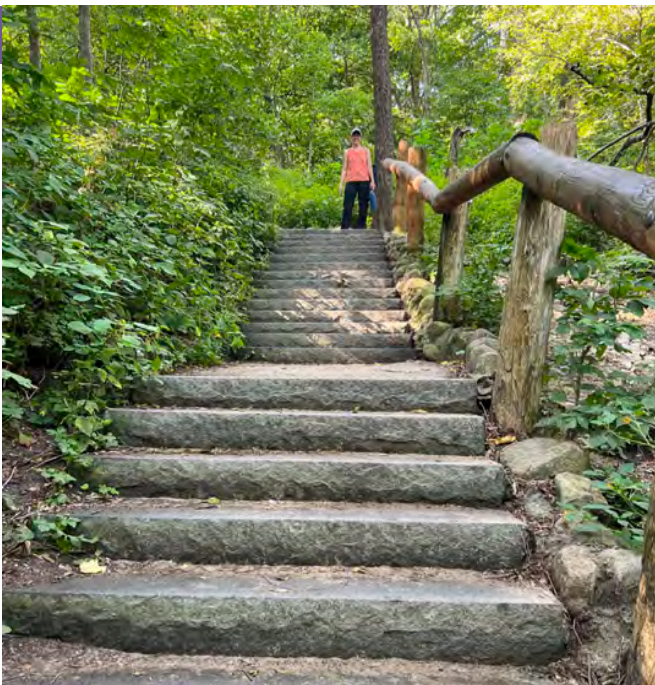
*Newer existing stair on the south side of the ravine to be used as model for proposed stair.*

We recommend installing a new stairway with a graspable handrail opposite the main bridge by the lake, utilizing part of the existing desire line path and working with the nearby topography. In this location, the stair can be constructed of stone slabs with connecting asphalt sections, similar to the stair south of the bridge. Alternately, a structured stair, potentially made with a combination of steel structure and wood planking and utilizing the already trampled bluff slope, should be studied. This area comes with soil stability and coastal challenges, but may be the most functional and preserve the remaining existing vegetation best.

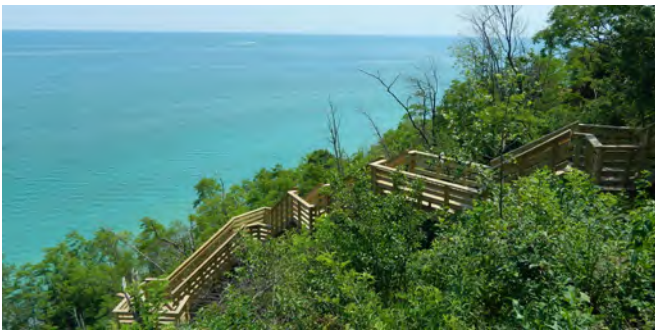
*Wooden bluff stair at Virmond Park. Photo courtesy of Ozaukee County.*

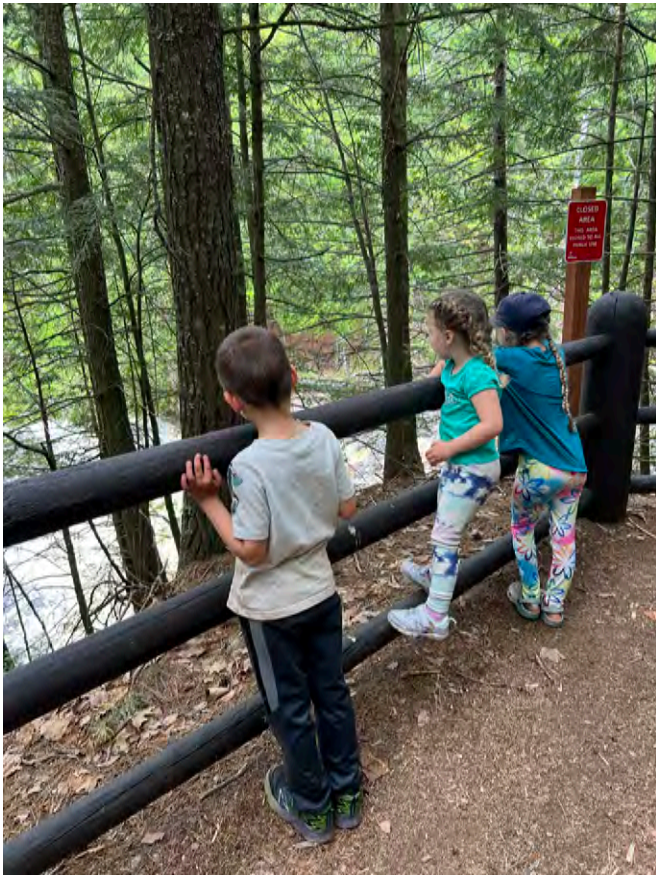
*Example log fence to be used at the top of the bluff to protect slope.*

Fencing is not the preferred method for keeping visitors on the trails, but it is necessary in certain key areas. The bluff along the lake is one of the park's steepest, most erodible areas and is being actively degraded by visitors. A standard County Parks log fence, similar to the one used south of the ravine, should be installed along the top of the bluff to provide a safe barrier and prevent visitors from traversing the slope. Another fence should be installed at the bottom of the slope, where most foot traffic originates, however, this can be a temporary welded wire fence set back from the beach to minimize visual impact. Temporary fencing, consisting of short metal stakes and connecting ropes, should also be installed between trails and restoration areas to signal that these areas are off-limits. These low-cost fencing options can also be used to keep visitors off the tops of walls and away from the stream.

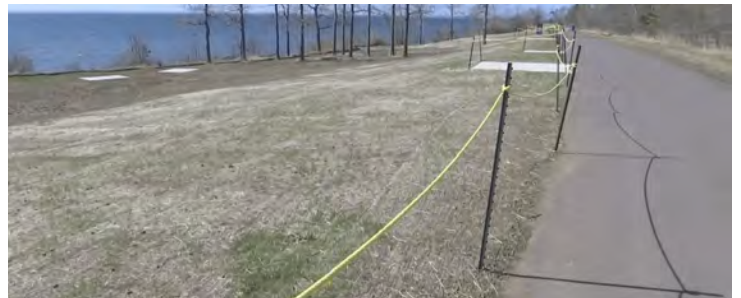
*Example temporary stake and rope fence to protect restoration areas.*

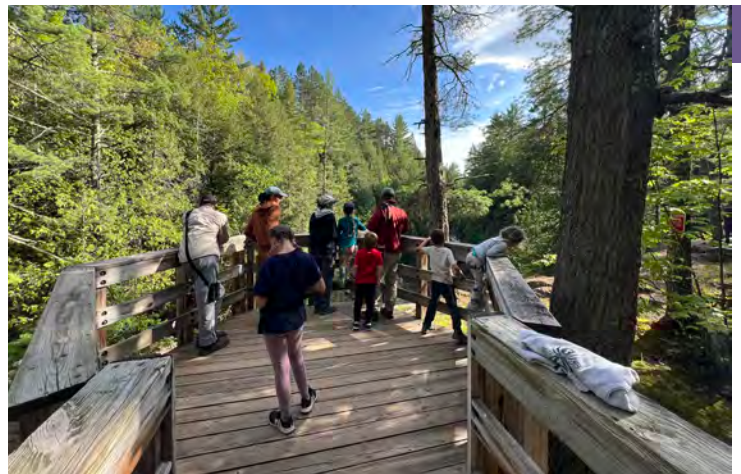
*Example overlook character.*

Boardwalks should be added where seepage causes trails to remain wet, where the soil has subsided, and where grading issues make traditional trails difficult to maintain. A boardwalk/overlook structure with a railing should be added at the top of the bluff setback from where the stream meets the beach. This area is the most severely eroded in the park, but it is also a popular point of interest for visitors. Adding this feature will create low-impact access at the top of the bluff while blocking access to the slope, preventing further erosion along the bluff.

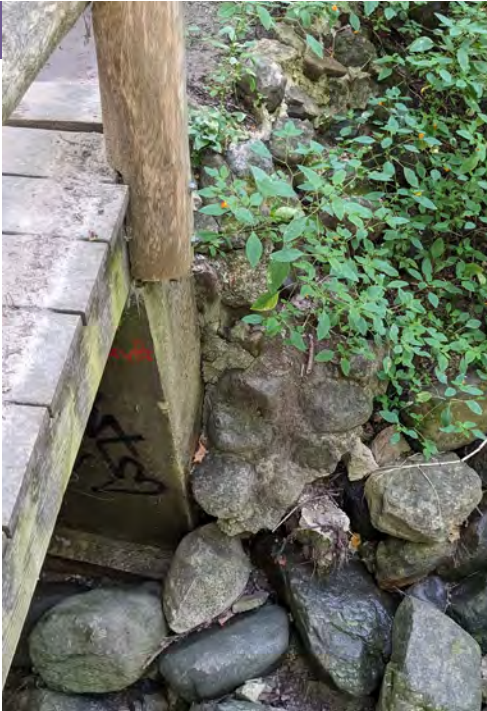
As the name of the area suggests, the bridges are a central feature of the park. Many of these historic bridges have been rebuilt over the years following major storms. While recent repairs have improved the bridge railings, several bridge foundations are at risk of being undermined by erosion. As indicated in the restoration map, stone toe protection should be added or repaired around select bridge foundations to safeguard them from future erosion. One particular bridge foundation is leaning and requires ongoing observation and further study to determine if reconstruction is necessary.

*Existing exposed bridge foundation.*

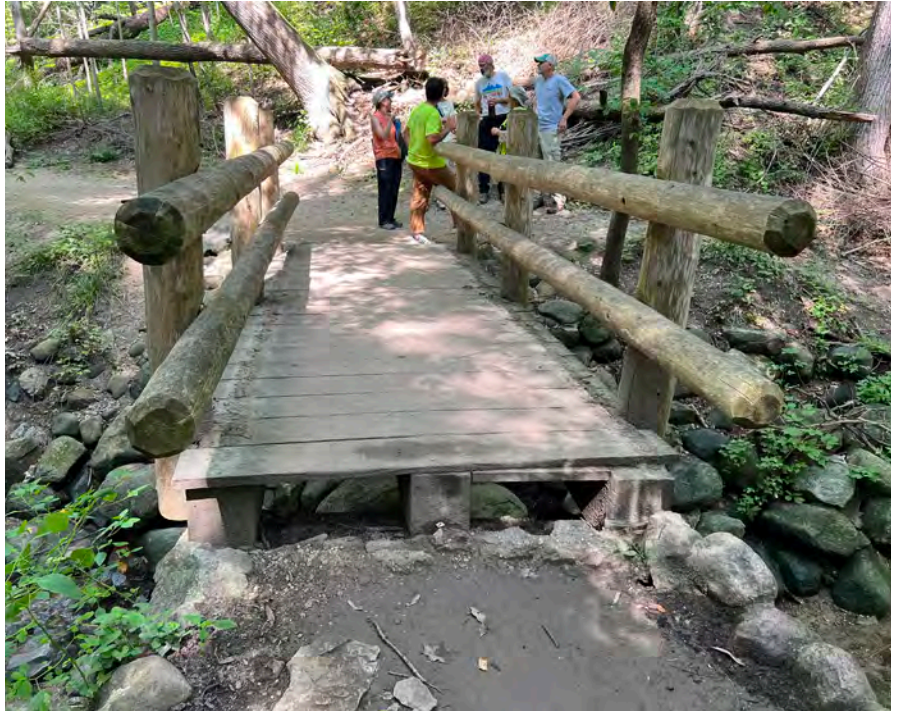
*Uneven trail and bridge surface with muddy landing area where a boardwalk connection is proposed.*

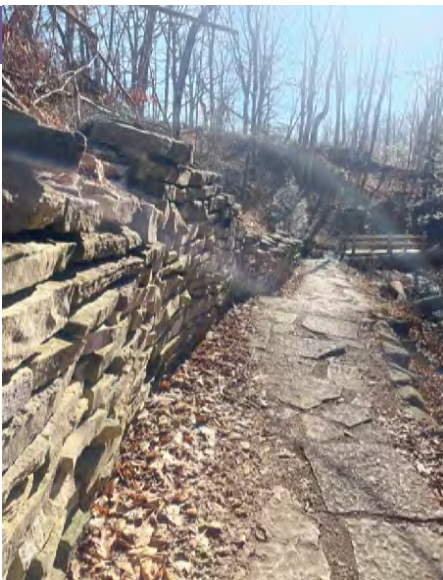
Vandalism, foot traffic on top of the walls, and age/hydrostatic pressure have contributed to the deterioration of the historic walls throughout the ravine. One major wall along the north branch of the ravine is leaning significantly and needs to be rebuilt. During reconstruction, care should be taken to stabilize the slope, and the existing stones should be reused as much as possible. Drainage should be installed behind the wall to relieve hydrostatic pressure. All walls should be protected by planting shrubs and herbaceous plants above them, with temporary restoration fencing to aid establishment. It was observed that a downed log on top of one wall prevented visitors from walking on it, allowing vegetation to re-establish. This could be considered as part of the restoration strategy.

*Existing leaning stone wall to be rebuilt.*

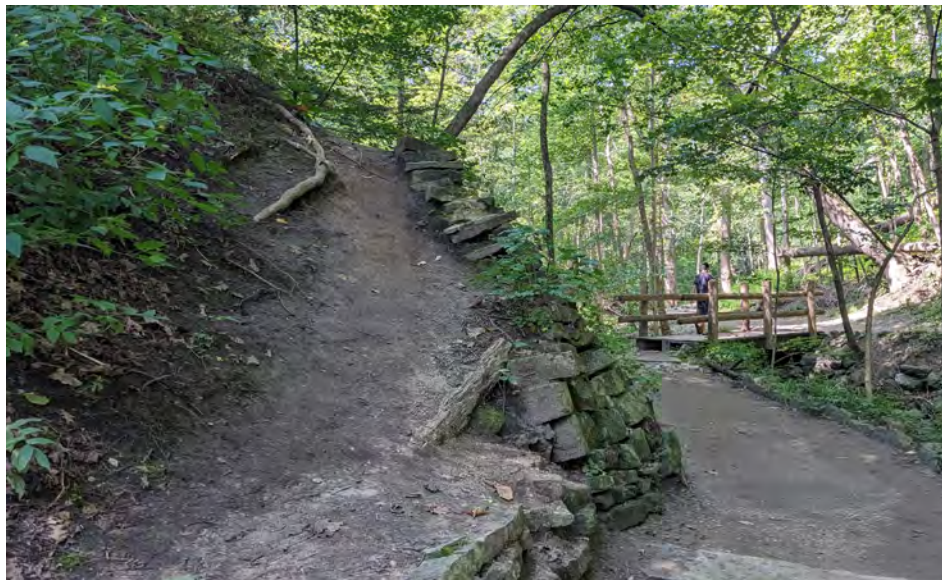
*Existing trails along the top of walls to be restored.*

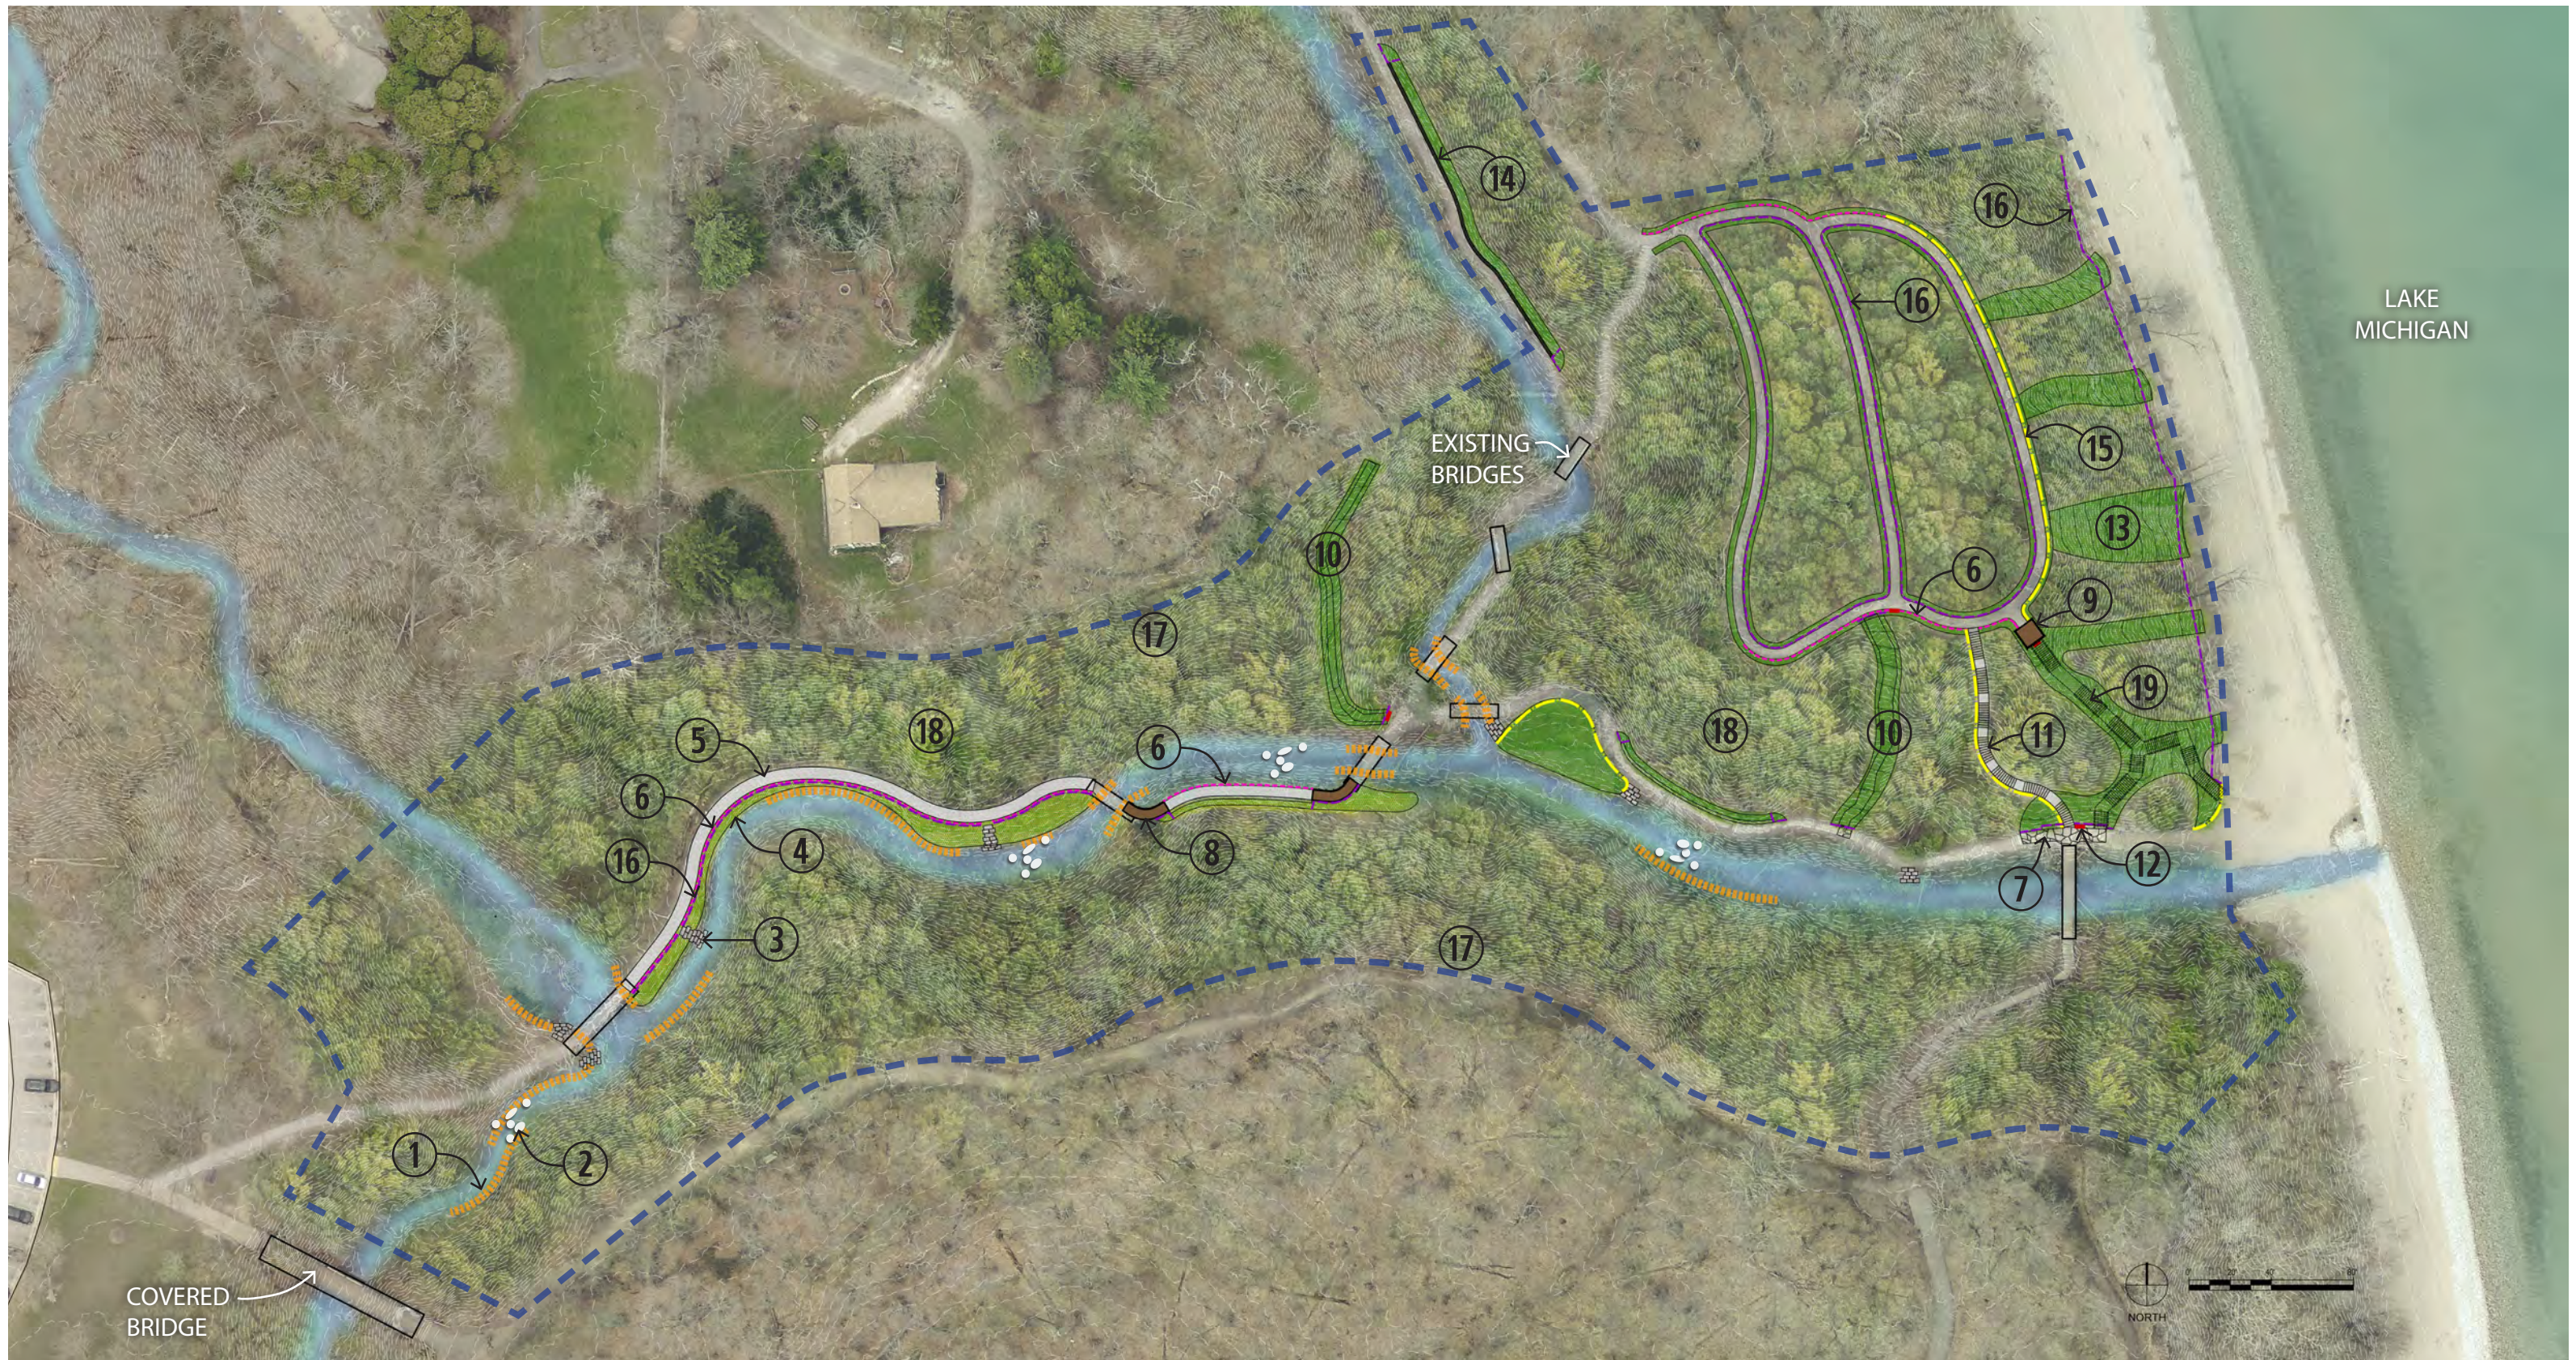
**PLAN KEY & LEGEND**

- ① Stone Toe Protection
- ② In-Stream Structure Repair
- ③ Water Access
- ④ Regrade, Fabric & Plant
